The July 20, 2017 Bodrum-Kos, Aegean Sea Mw = 6.6 earthquake; preliminary field observations and image-based survey on a lateral spreading site

George Papathanassiou^{a,*}, Sotiris Valkaniotis^b, Spyros Pavlides^c

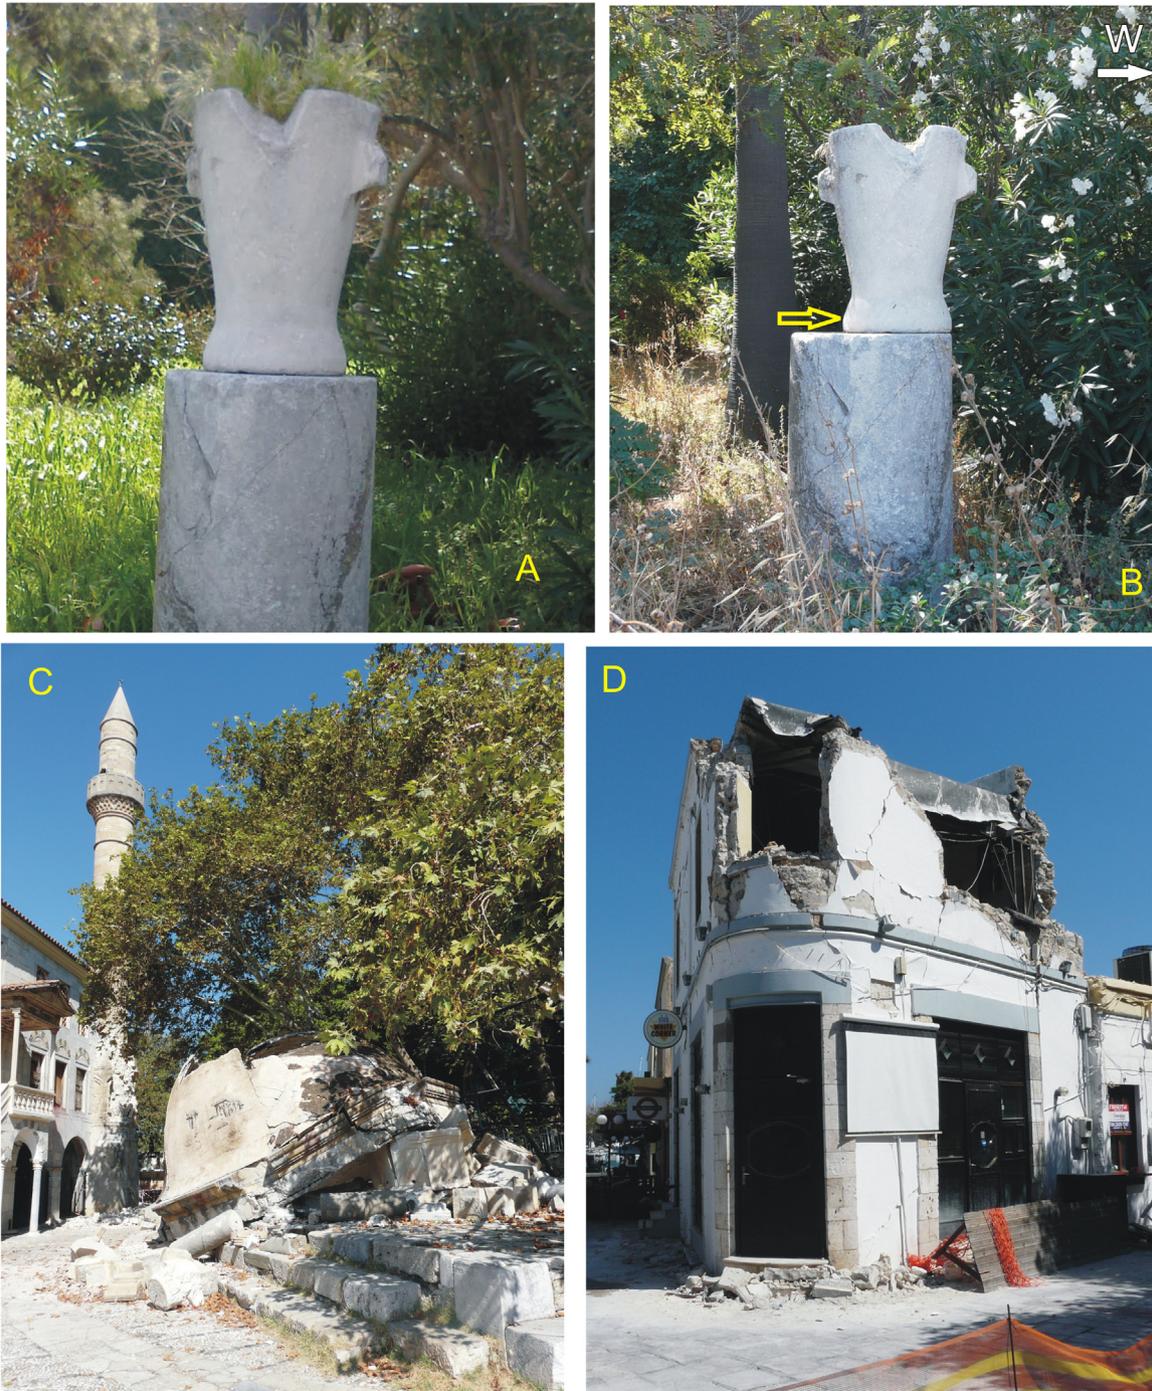
Fig. 3. A) Pre-earthquake photo of the site (photo uploaded by Sofia Karagianni on 24 March 2012, on Panoramio Google earth), b) Horizontal movement of the statue parallel to the direction of the shaking, c) One of the two fountains of the Gazi Hasan Pasha Mosque, located at the old part of the city of Kos, was completely collapsed d) heavily damaged building at the old part of the city of Kos (photographs b,c and d taken by G. Papathanassiou on August 14, 2017).

Regarding the earthquake-induced failures to the manmade environment, minor damages were observed on contemporary residential houses and buildings that were constructed following the regulations of the Greek Seismic Code. However, severe damages have been observed on constructions of Ottoman and Venetian-era. The locations of these failures are shown in Fig. 2b. In particular, the castle of Nerantzia, built by the knights of St John in the mid-14th century at the entrance of the old harbor on the eastern part of the city, was seriously damaged and a crack of 10 cm opening was reported in the northwestern wall. At the same area, which is located between the western side of the castle and the heavily damaged custom building, a lateral shifting of a statue towards the west was documented. The direction of the movement is parallel to the direction of the causative fault (Fig. 3a and b).

At the area of castle, we have been informed that a mixture of soil and water was ejected through an abandoned well, and that the ejected grey material covered the area around it (M. Lefatzis and M. Chalkiti personal communication). Opposite the castle of Nerantzia at Lotzia Square, near the “tree of Hippocrates”, the Gazin Hasan Pasan Mosque that was built in 1786 was heavily damaged (Fig. 3c) and the local authorities forbade the public entrance. In addition, two people killed when an Ottoman-era house partially collapsed (Fig. 3d).

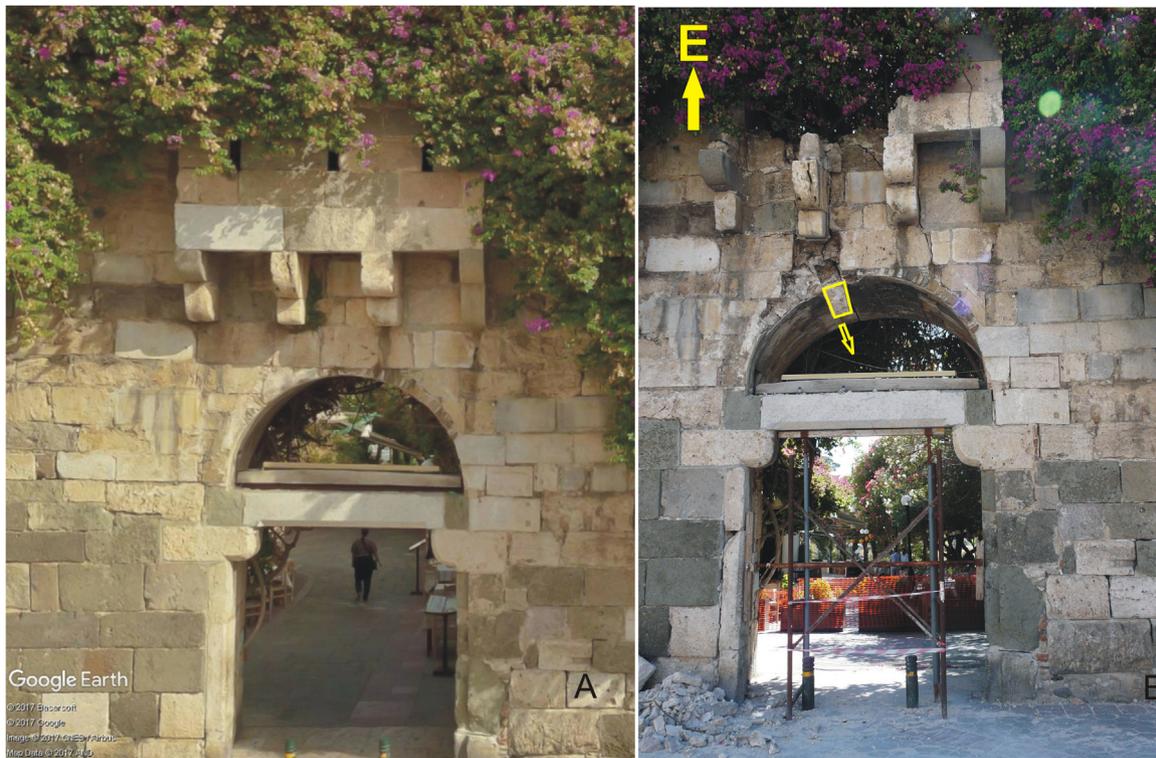
Fig. 4. A) Pre-earthquake photo of the arch (photo taken on October 20, 2015 and uploaded by Kos tourism on Panoramio, Google earth), b) post-earthquake photo showing the downward movement of the keystone (yellow color) (photo taken by G. Papathanassiou on August 14, 2017) (For interpretation of the references to color in this figure legend, the reader is referred to the web version of this article.).

Moreover, at the centre of the old city of Kos and particularly, at the Kazouli Square the Deftedar mosque and the Ancient gate to Roman Agora were damaged. In the latter case, the downward movement of the keystone in the arch (Fig. 4b) is considered as a typical earthquake effect on archeological sites. In particular, according to Kamai and Hatzor [23], this type of secondary effect can be induced only by major earthquakes ($M > 6.5$), and is usually developed due to a decreasing load to the walls of the arches. Furthermore, the occurrence of the downward sliding of the keystone is related to the seismic shock direction. In particular, Rodríguez-Pascua et al. [24] stated that this sliding can be developed only when the angle formed by the seismic direction and the arch is smaller than 45° . However, this conclusion is

not in agreement with this case study (Bodrum/Kos 2017 event), since the relevant angle is much larger than 45° . This case of earthquake archeological effect (EAE) will be further analyzed in near future when quantitative data will be available. The reader is referred to the article of Rodríguez-Pascua et al. [24] for more information regarding the usefulness and analyses of the EAE in seismic hazard analysis.

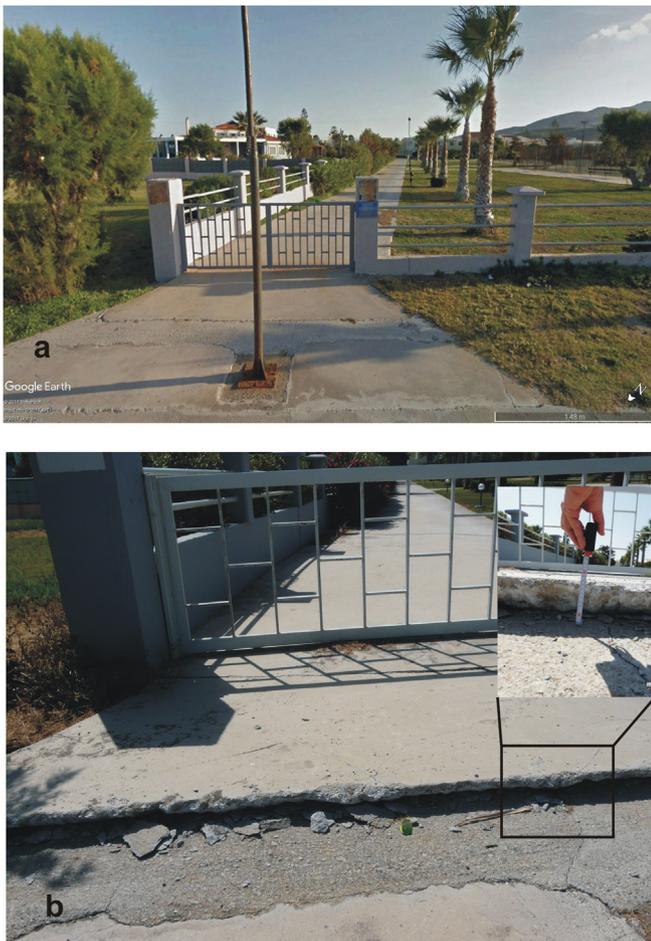
Regarding the generated secondary ruptures/cracks on the island of Kos, it was feasible to map them at the eastern part of the island close to cape Louros (location is shown in Fig. 2a). In particular, a crack on the paved road of an average width of 3 cm was observed. Along this direction at a distance of few meters to the west, the pavement was cracked and two distinct segments were formed. As it is shown in Fig. 5b, the inner part overimposed upon the outer one creating a “step” of 10 cm vertical displacement that resulted to the closure of the entrance of the nearby hotel.

Fig. 5. A) Pre-earthquake photo of the entrance (©2017 Google earth), b) post-earthquake cracks at the same location (photos taken by G. Papathanassiou on August 13, 2017).

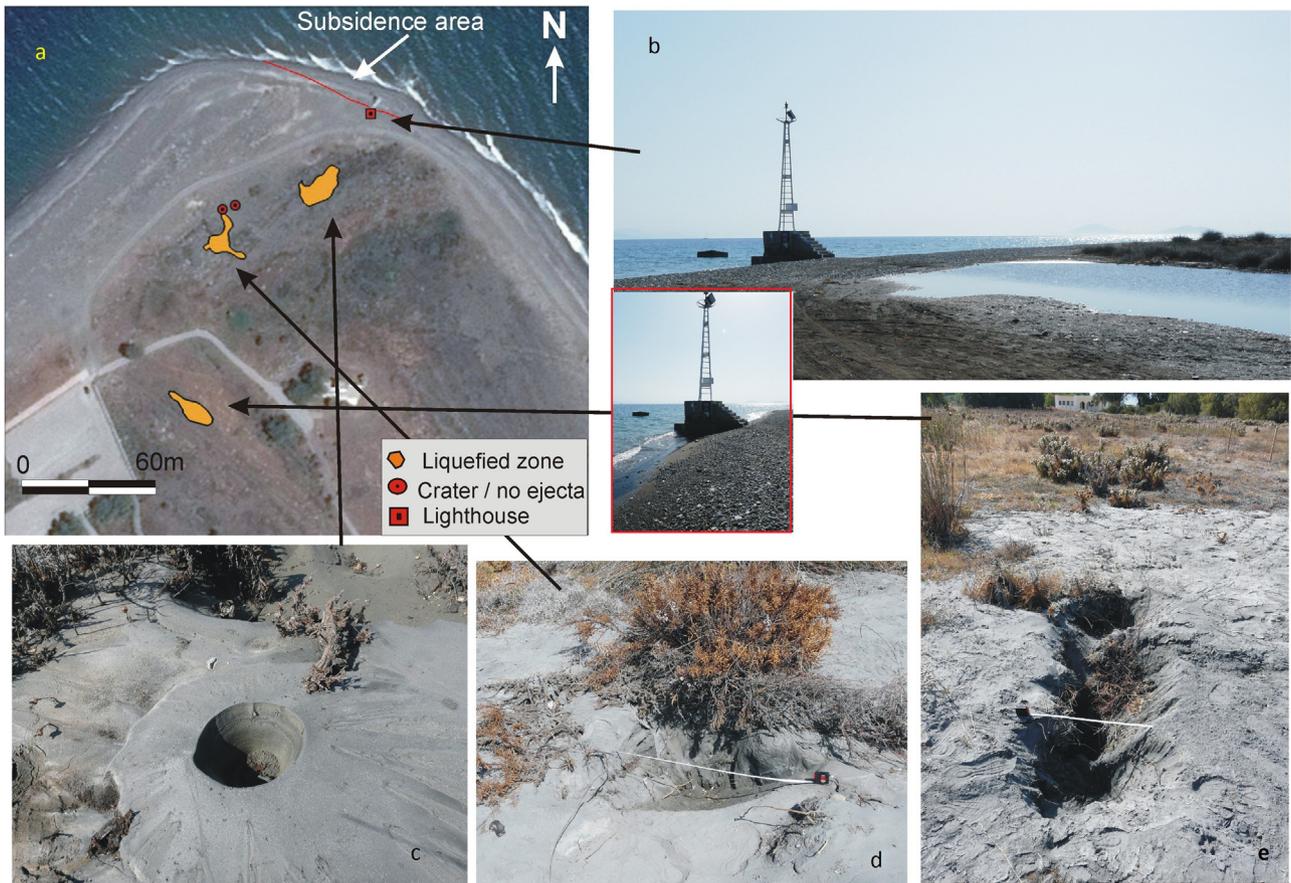
cracks covered more than 450 m^2 (Fig. 7). During the post-earthquake reconnaissance field survey, we used the “track” function in a GPS handle unit in order to accurately map the liquefied zones and document their dimensions; area (m^2), perimeter (m) and centroid per zone (Table 1). In particular, we used the GIS kit app (© 2017 Garafa, LLC) and the Bad elf GPS for lightning connector for iPad 2. The web tool used for the accomplishment of this goal is the one developed for the purposes of LAMPRE Project (<http://www.lampre-project.eu/>), aiming to document landslides. As it is presented in this study, this tool can additionally be used for mapping areas covered by liquefied material.

At the liquefied zone 1, a ground crack of 2 m length, 50 cm width and 40 cm depth was documented through which grey color mixture of soil and water was ejected and covered 142 m^2 (Fig. 7e). The perimeter of the covered area is 57 m and the centroid of the area is on 36.8892938° , 27.3375461° . At zone 2, the mixture of soil and water was ejected through a sand crater of 12 cm diameter and a nearby ground crack with dimensions of 24 cm width, 50 cm length and 11 cm depth, and covered 208 m^2 (Fig. 7c). The perimeter of the area is 64 m with centroid on 36.8902587° , 27.3382231° . At the third zone, the liquefied material was ejected through a crack of 80 cm width, 90 cm length and 55 cm depth (Fig. 7d). The ejecta covered 139 m^2 and the perimeter of the area is 77 m with centroid on 36.8900282° , 27.3377017° . Soil samples from these three liquefied zones were collected and analyzed in the laboratory of Engineering Geology and Hydrogeology of Aristotle University of Thessaloniki; the results are presented in Section 5.3. At the same location, a subsidence of the coastal area was documented. The post-earthquake position of the lighthouse, which was initially constructed 10 m far from the coastline, is now practically standing on it due to subsidence and the inundation of the coast (Fig. 7b). At the same area, two craters of an average of 50 cm diameter were reported without any evidence of liquefaction origin ejecta.

Fig. 7. Earthquake-induced ground failures at the cape Louros (all photos taken by G. Papathanassiou on August 13, 2017). A) Plan view of the area (background image from ©2017 Google earth) showing the location of the reported secondary effects, b) subsidence and inundation of the coast at the area of the lighthouse, c) sand crater at the liquefied zone 2, d) ground crack through which liquefied material was ejected at the liquefied zone 3, e) ground crack through which liquefied material was ejected at the liquefied zone 1.

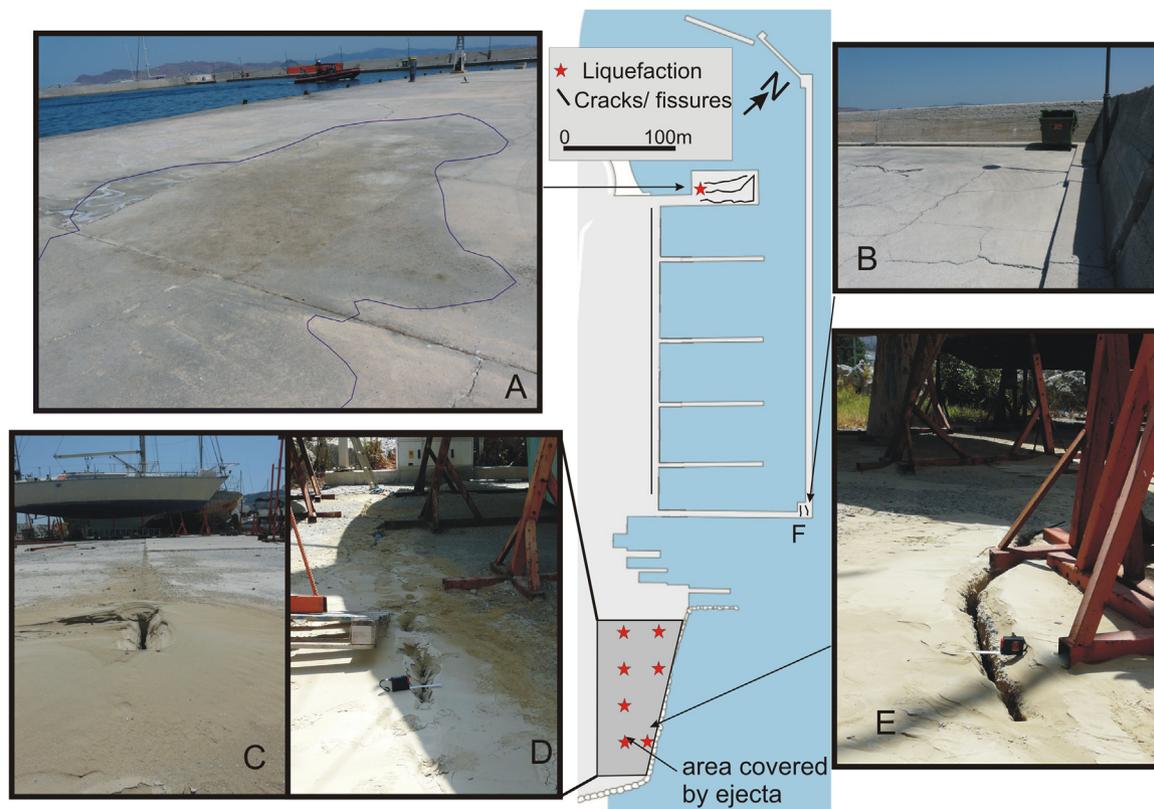
The marina of the island of Kos was constructed on 2001 and is located at a distance of 1 km to the east of the capital of Kos. At this area, extremely large amount of brown material was ejected through cracks of up to 8 cm width on the pavement aprons (Fig. 8). The ejecta covered almost all the area that is used as a dry dock and for the maintenance and repairs of sailboats and yachts (Fig. 8c, d and e). Furthermore, the liquefaction of the subsoil induced failures to the lifelines; according to a witness the pipelines were broken. One sample was collected from the ejecta and analyzed, showing that the dominant particle size of the material is sand. In addition, the earthquake induced structural failures at the main area of marina and particularly, cracks of 4–5 cm width were observed on the sidewalk with direction parallel to the seashore. At the main pier, cracks on the pavement aprons with horizontal and vertical displacement were documented and an area of approximately 30 m^2 covered by ejected material (Fig. 8a). It must be pointed out that these cracks were not parallel to the seashore. At the same area, at pier F, a system of cracks on the pavement induced a subsidence of the site forming a “graben” (Fig. 8b).

Fig. 8. Liquefaction-induced failures documented at the area of marina (all photos taken by G. Papathanassiou on August 13, 2017), a) ejected material at the main pier, b) cracks at pier F, and c,d,e) liquefaction manifestations at the area of marina that is used as a dry dock and for the maintenance and repairs of sailboats and yachts.

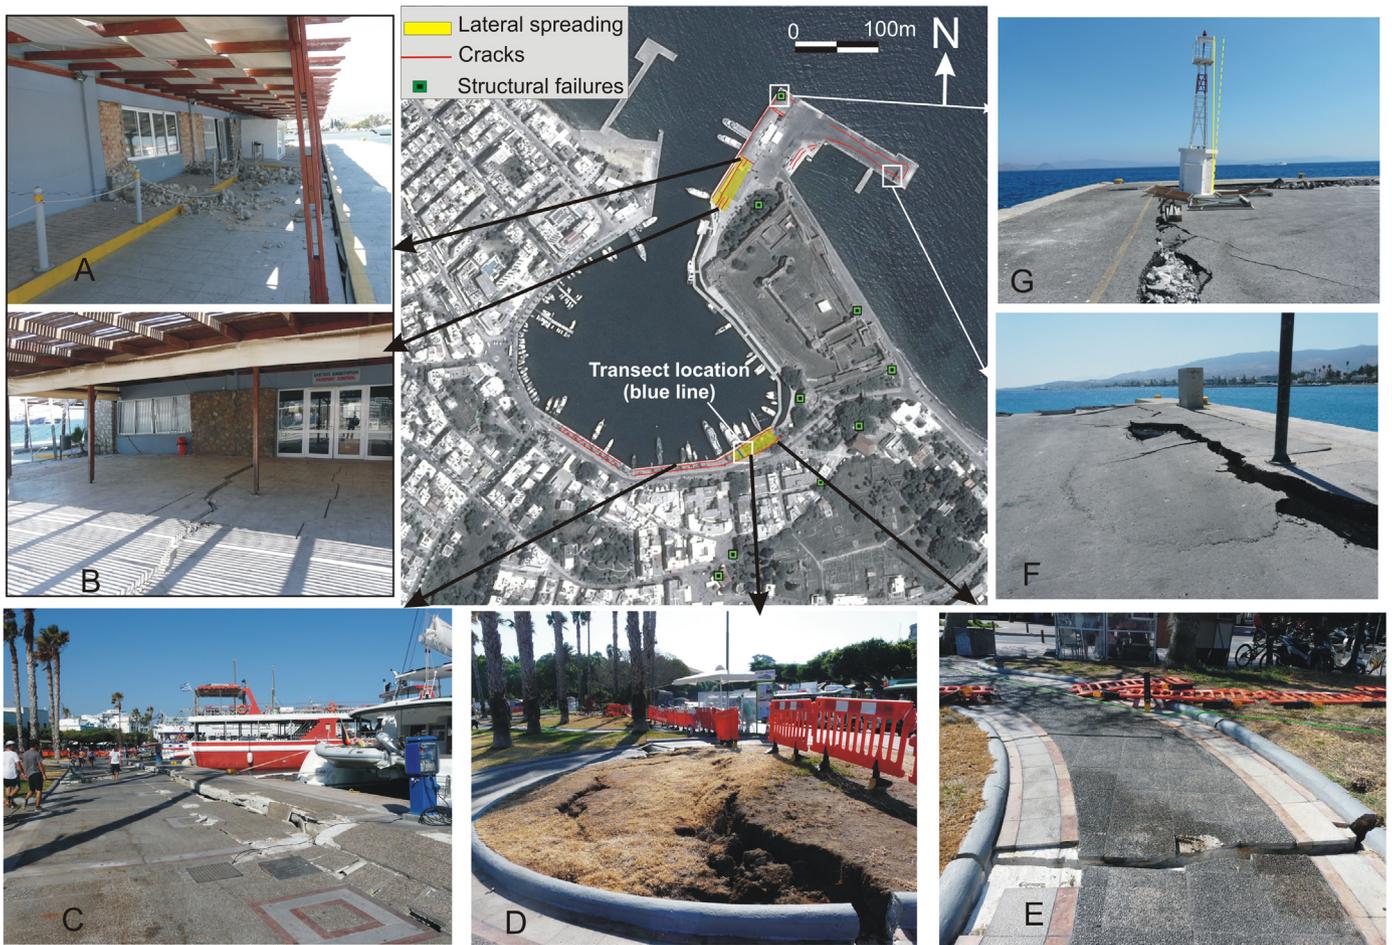
In particular, parallel cracks on the pier of 10–15 cm width that were developed due to lateral spreading phenomena, resulting to the totally loss of functionality of the port and of the custom building (Fig. 9a and b). Walking parallel to the seashore towards the lighthouse, a crack of 100 m length was reported behind the quay wall. The horizontal and vertical displacement along this crack varied with

maximum subsidence of 35 cm at the edge of the pier. At this site, a tilting of 6 degrees of the lighthouse was measured (Fig. 9g). A perpendicular crack to the seashore on the pavement aprons and the parallel to the seashore crack, formed a graben-like phenomenon at the main dock of the port.

documented. In particular, a fissure of up to 5 cm wide on the sidewalk and a parallel crack behind the quay wall with horizontal displacement of up to 10 cm and up to 35 cm vertical offset, induced severe subsidence (Fig. 9c). Moving towards the castle, the cracks were extended to the nearby park where lateral spreading phenomena were observed in a distance of 12 m from the seashore (Fig. 9d and e). This area was studied in detail and the results are presented in the Section 5.4.

Fig. 9. Liquefaction related phenomena at the waterfront area of the city of Kos (all photos taken by G. Papathanassiou on August 14, 2017). A and B) lateral spreading phenomena induced damages to custom building, c) subsidence behind the quay wall at the old harbor, d,e) lateral spreading phenomena at the old harbor, f) failure at the new port of Kos, g) subsidence of 35 cm behind the quay wall at the main pier and tilting of 6° of the lighthouse. Background image of the plan view from © 2017 Google earth.

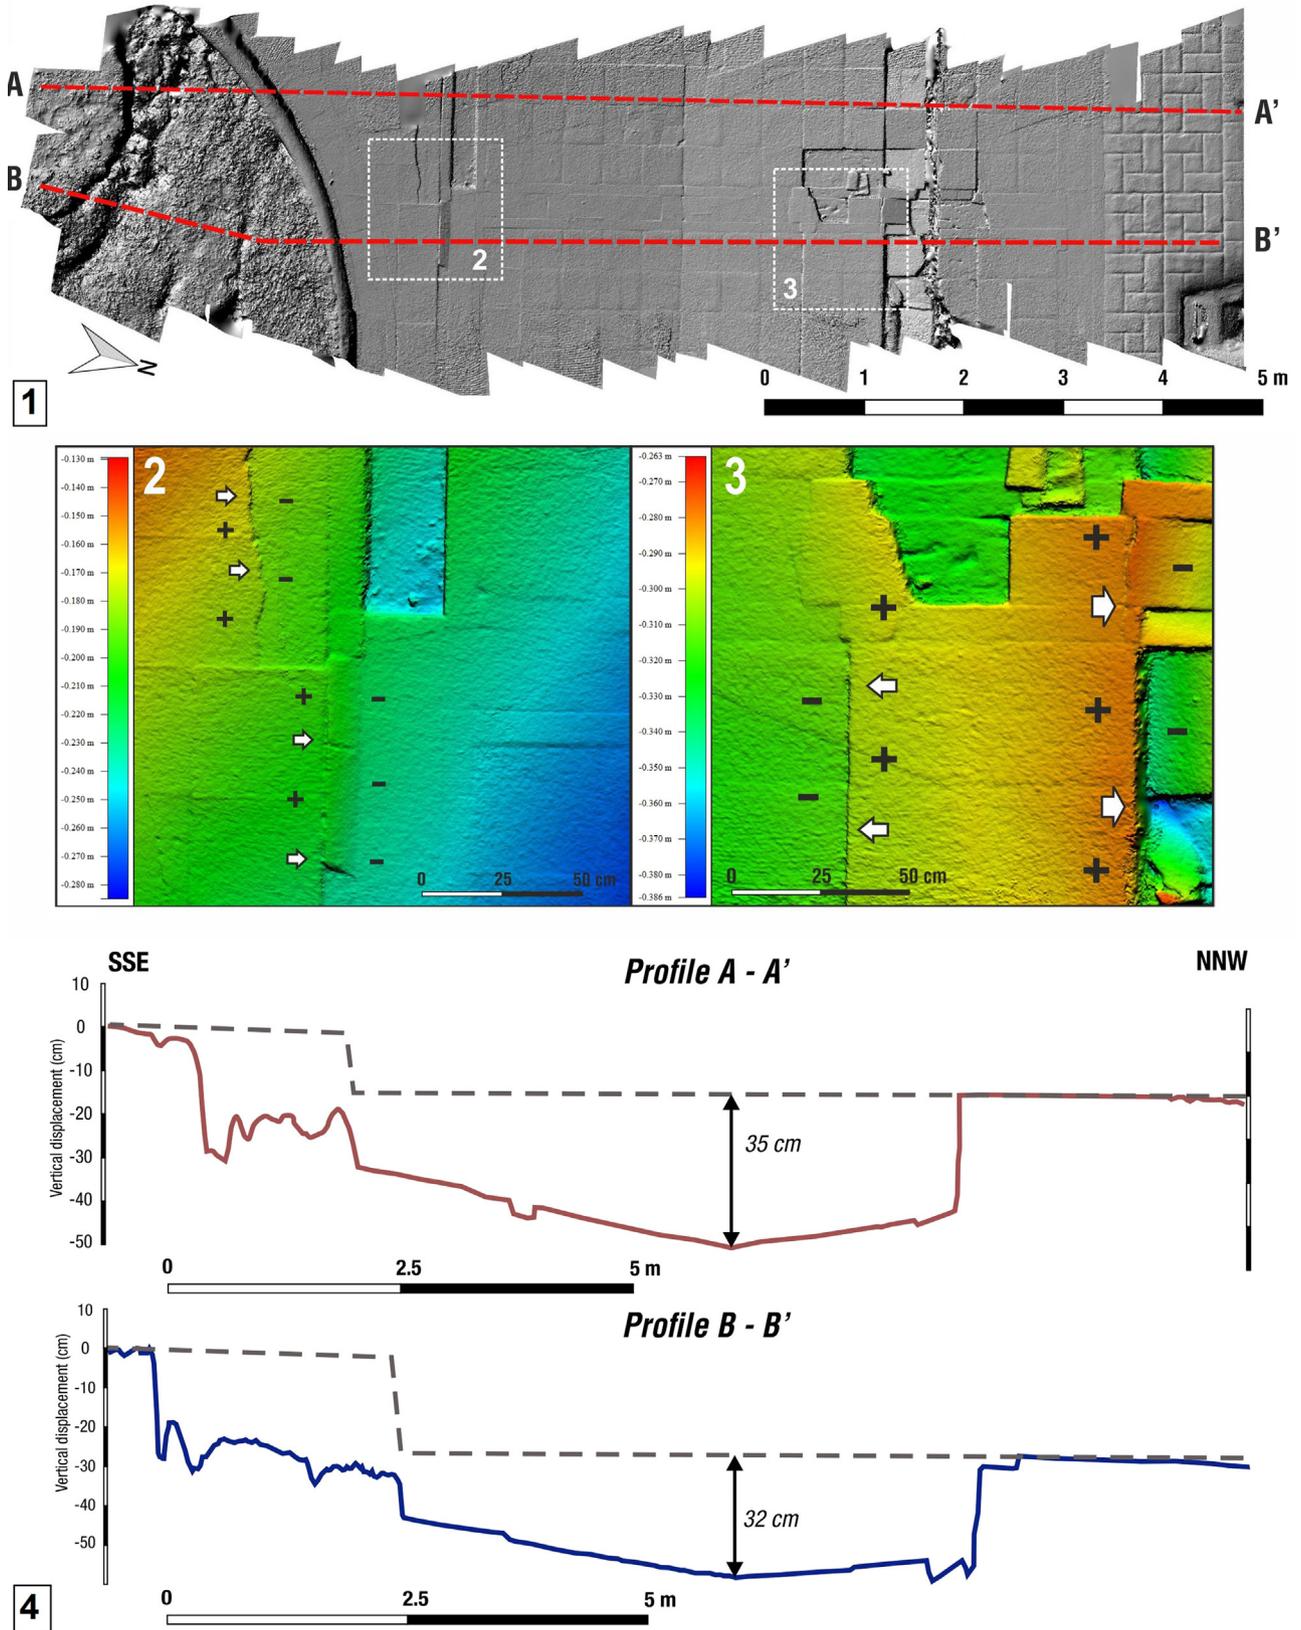
Fig. 11. 1. Shaded relief of digital surface model (0.3 cm pixel) extracted from the point cloud 2 and 3) Details from the digital surface model showing minor deformation structures and cracks (arrows). 4) Profiles showing complex vertical displacement along the lateral spreading feature. Dashed lines represents pre-earthquake surface. Maximum vertical deformation is calculated by the profiles at -35 and -32 cm.

The outcome of SfM approach is shown in Fig. 11. In particular, initially a shaded relief of digital elevation model (0.3 cm pixel) was extracted from the point cloud dataset. In order to measure the maximum vertical offset, the point cloud obtained from the photogrammetric survey, was compared with a pre-earthquake ground surface profile. The latter one was reconstructed by taking into account pre-earthquake images of the specific location and descriptions provided by local authorities. As it is shown in Fig. 11, the maximum earthquake-induced vertical displacement is 35 cm, and was documented behind the quay wall.

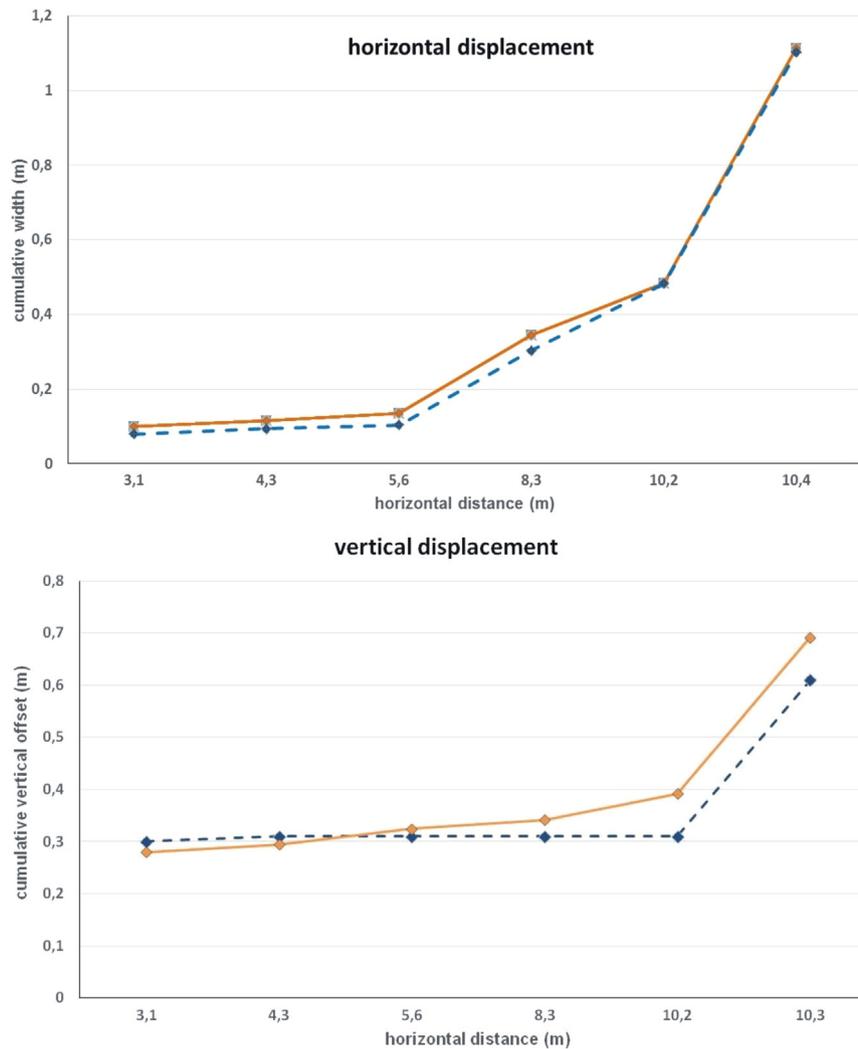
Fig. 12. Comparison of the cumulative horizontal displacements measured during the field survey (blue dashed line) with the ones provided by the SfM-based 3D point cloud (orange solid line), Profile A-A' in Fig. 11. Top) horizontal displacement, bottom) vertical displacement (For interpretation of the references to color in this figure legend, the reader is referred to the web version of this article.).

Furthermore, having developed the 3D point cloud, we were able to measure the cumulative width of cracks and the vertical displacements following the photogrammetric technique at Profile A-A' (Fig. 11). After that, the SfM measurements were compared with the ones obtained by the traditional field survey i.e. manual measurements. In particular, the distributions of the lateral spread displacements that were measured by these two techniques are listed in Table 2 and shown in Fig. 12. The cumulative width of the cracks, measured based on SfM technique, is 1.1145 m, and fits very well to the one measured by the traditional technique e.g. 1.1035 m (Fig. 12a); less than 1% deviation. The deviation for the cumulative vertical offset is approximately 12%, which can be considered as significant. It must be highlighted that this value is mainly resulted from the measurements for horizontal distance of greater than 8 m (Fig. 12b). In particular, as it is presented on Table 2, the vertical displacement measured based on SfM technique at 8 and 10 m distance from the seashore is 0.017 and 0.05 m respectively. At the same distances, no displacement was identified on the field during the traditional survey and consequently the relevant values are zero for both locations. As a result, the cumulative offset measured based on SfM is 0.692 m, while the one measured using a surveyor's tape on the field is 0.61 m (Fig. 12b).
