The July 20, 2017 Bodrum-Kos, Aegean Sea Mw = 6.6 earthquake; preliminary field observations and image-based survey on a lateral spreading site

George Papathanassiou^{a,*}, Sotiris Valkaniotis^b, Spyros Pavlides^c

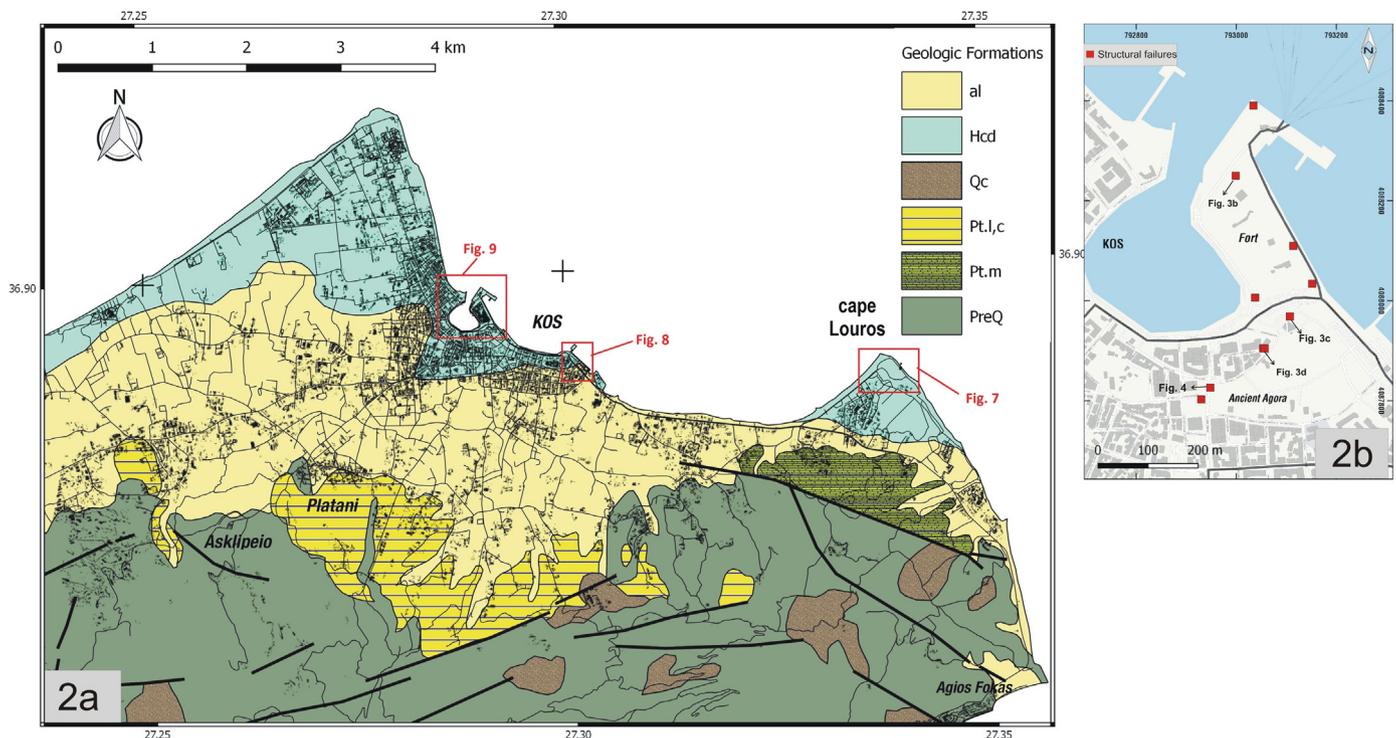
Fig. 2. a. Map of Quaternary sediments in the eastern Kos area; al: Alluvial deposits, Hcd: Coastal & lagoonal deposits, Qc: Quaternary scree and debris, Pt.l,c: Pleistocene lacustrine and terrestrial deposits, Pt.m: Pleistocene marine deposits, PreQ: Pre-Quaternary formations (Geologic data modified from Triantafyllis [22]). Fig. 2b. Locations of structural failures induced by the 2017 earthquake at the city of Kos.

The coastal eastern part of Kos island consists of a broad strip of Holocene coastal and lagoonal deposits (sands, silt and gravel), and an alluvial plain of sand, gravel, conglomerates and clay deposits (Fig. 2a). Quaternary scree and debris are mapped to the southern part of the island. Pleistocene shallow marine to terrestrial deposits can be found at the hills located to the south and east of the city of Kos. They consist of a variety of conglomerates, tuffs, terrace deposits, sands, sandstones, marls and marly limestones (Altherr et al. [20]; Willmann [21]; Triantafyllis [22]).

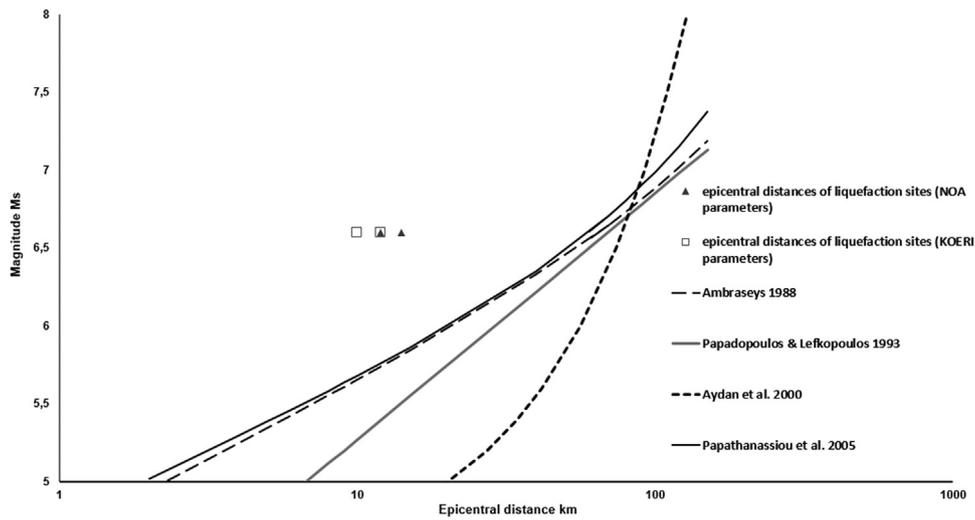
Fig. 6. Distribution of the liquefied sites and comparison to the proposed upper bound curves for the assessment of liquefaction susceptibility.

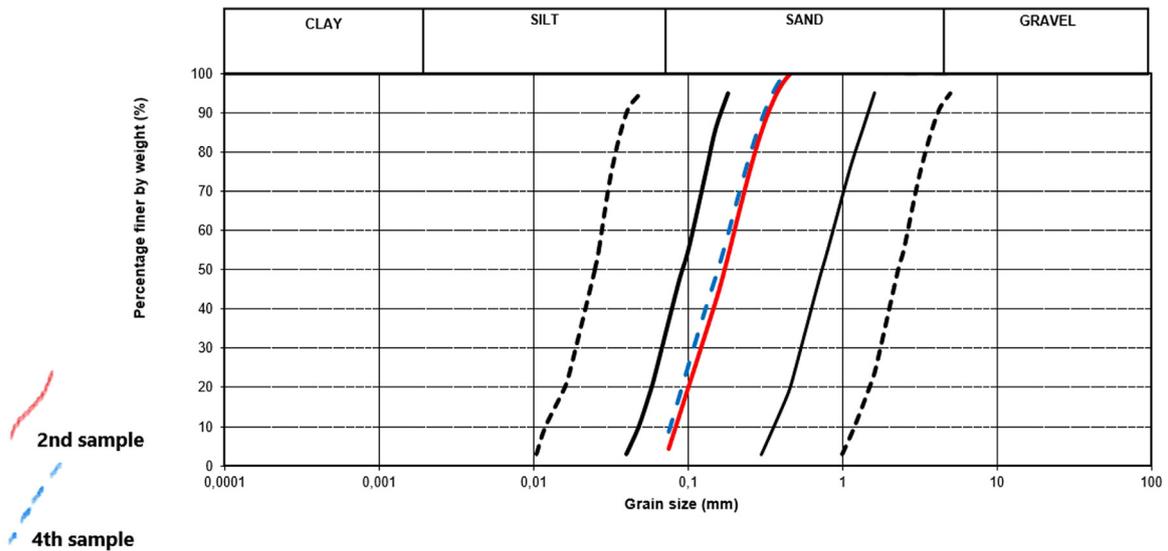
Taking into account that the 1st, 2nd and 3rd sample were collected from the same area (cape Louros) and that their gradation is similar based on the conducted grain size analysis, it was decided to plot in Fig. 10 only one gradation curve with red solid color e.g. 2nd sample, in order to facilitate the reader. The 4th sample that collected at the area of marina is represented by a blue dashed line. As it is shown in Fig. 10, the particle size distribution curves of the collected samples are in the range of likely to liquefaction soils, defined by Tsuchida [30].

Fig. 10. Grain size analysis of the collected samples and comparison with boundary lines proposed by Tsuchida [30]. Red solid line represents the gradation curve of the 2nd sample and the blue dashed line shows the grain size distribution of the 4th sample. Solid black lines delineate the likely to liquefaction area, and the dashed black lines delineate the possible to liquefaction one (For interpretation of the references to color in this figure legend, the reader is referred to the web version of this article.).
